SPACE ENVIRONMENTAL EFFECTS ON LDEF LOW EARTH ORBIT EXPOSED GRAPHITE
REINFORCED POLYMER MATRIX COMPOSITES

Pete George
Boeing Defense & Space Group
Seattle, Wa

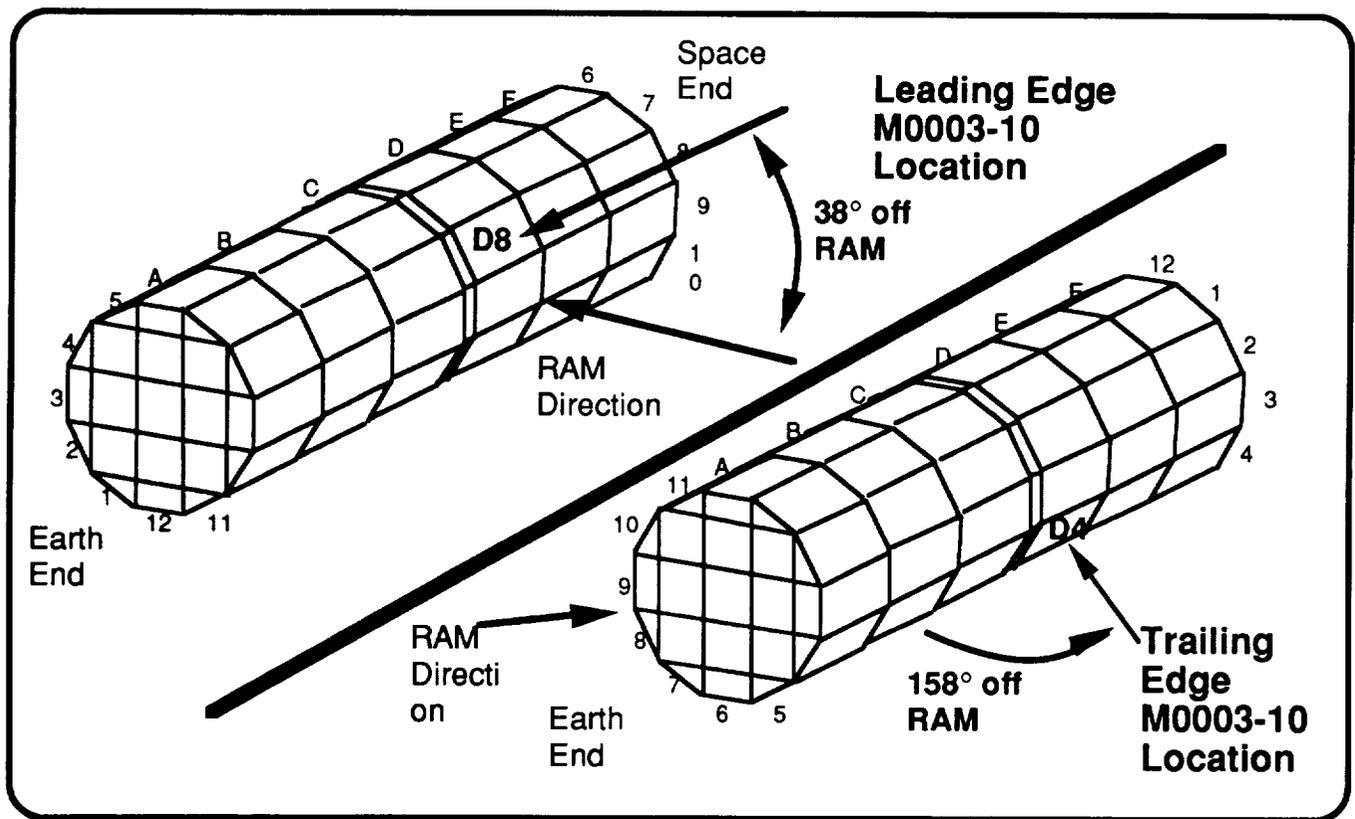
Figure 1. Location of M0003-8 experiment on LDEF

The M0003-10 Advanced Composites Experiment was located at both the leading and trailing edges of the LDEF as shown in Figure 1. The leading edge specimens were at position D8 on the satellite which was 38 degrees from the direction of motion (ram direction). The trailing edge specimens were located at position D4, 158 degrees from the ram direction.

The specimens of experiment M0003-10 were intentionally positioned at both leading and trailing edges in order to provide varied exposure conditions. At the mission altitudes the atomic oxygen was swept by the LDEF leading edge surface. The trailing edge specimens received practically no atomic oxygen exposure.

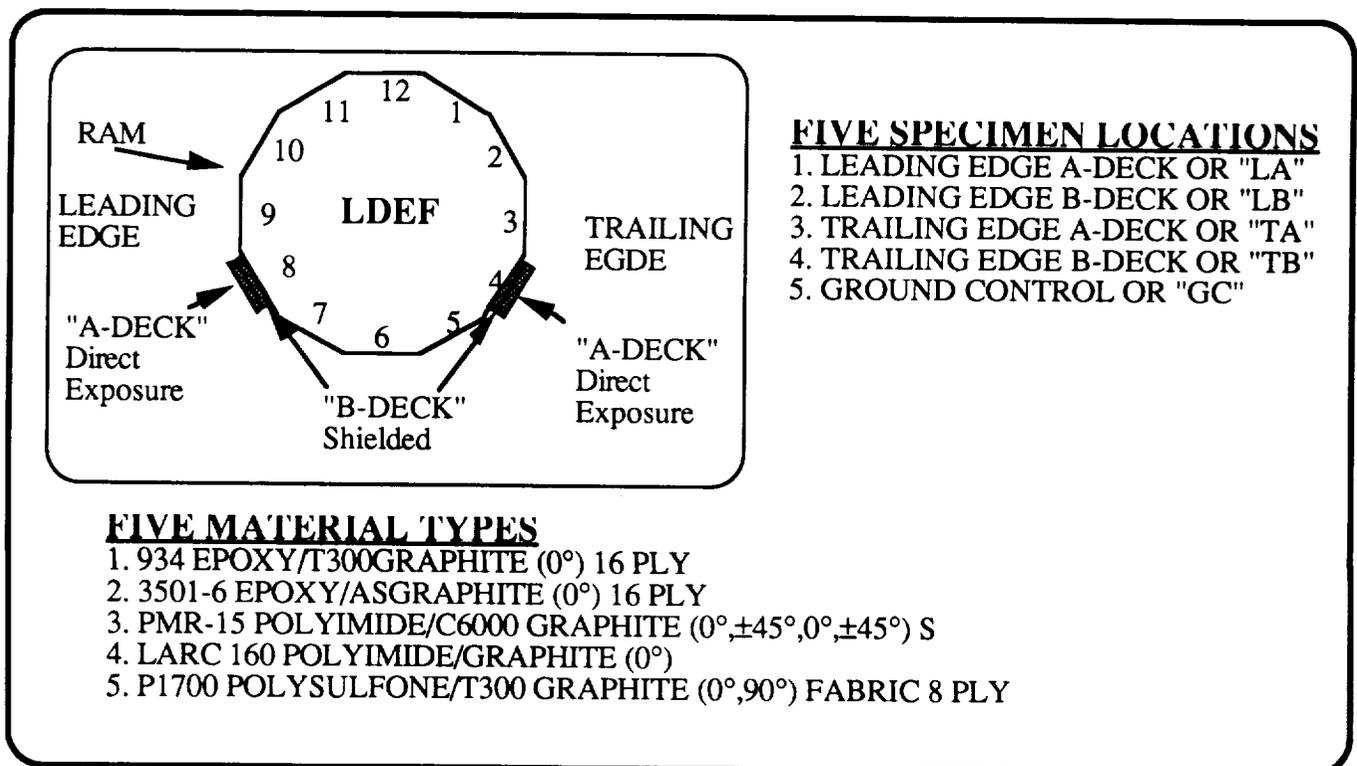
Figure 2. Material types and locations

Graphite fiber reinforced polymer matrix composites were located at both the leading and trailing edge positions as shown in Figure 2. Complete sets of the five material types listed in Figure 2 were flown in both direct space exposure positions on the "A-deck" as well as in shielded positions on the "B-deck" at the leading and trailing edges. Also, a complete set of specimens were kept at controlled temperature and humidity conditions at the Aerospace Corporation. These specimens were shielded from exposure to ambient light and were used as ground controls.

Specimen configuration was 3.5 inches long by 0.5 inches wide with the 0 degree direction parallel to the length. Thickness of the specimens varied between matrix types due to differences in number of plies and ply thickness. Matrix resins and reinforcements along with ply stacking sequences for the specimens are listed in Figure 2. The original documentation does not list the specific type of reinforcement for the LARC 160 polyimide. However it is known that the fibers are of the low modulus (33 Msi) range as are all of the reinforcing fibers for these specimens.

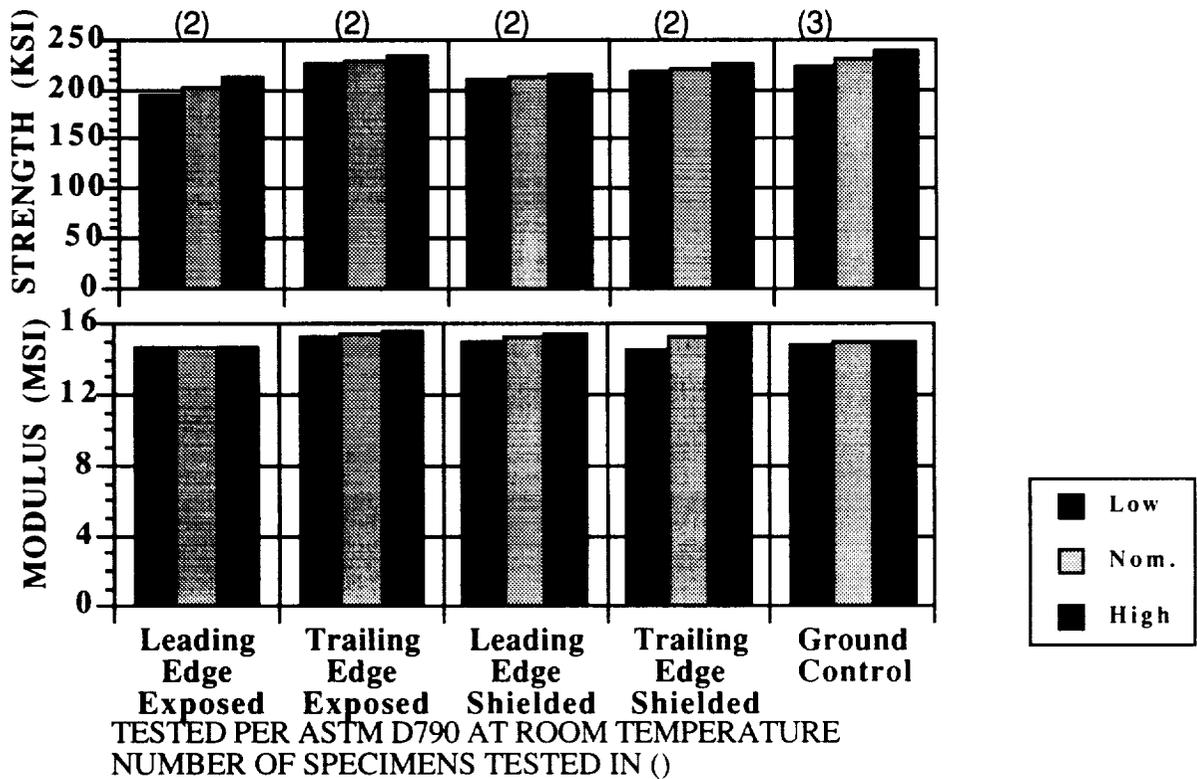
Figure 4. Flexure strength and modulus of 934/T300 specimens, (0°) 16 plies

The 934 epoxy/T300 graphite specimens did not show any significant loss in flexure properties between the different positions on LDEF and the ground control. These results are based on the post flight cross-sectional areas. The loss of material for the leading edge exposed specimens results in a performance reduction for a given specimen. As these specimens were unidirectionally (0°) reinforced, the load that would have been carried by the eroded material on the leading edge exposed specimens was carried by the remaining 0° material. For these specimens the only mechanical performance loss was due to material loss on the leading edge exposed specimens. Ply orientation plays a significant role in flexure properties behavior when AO erosion is involved.

Figures 4 through 8 show the flexure test results for the space exposed, shielded and ground control specimens. Three point flexure testing was performed per ASTM D790 using an Instron model TT-D equipped with a deflectometer. A cross head speed of 0.1"/minute and a 21T span to depth ratio were used. All testing was performed at room temperature.

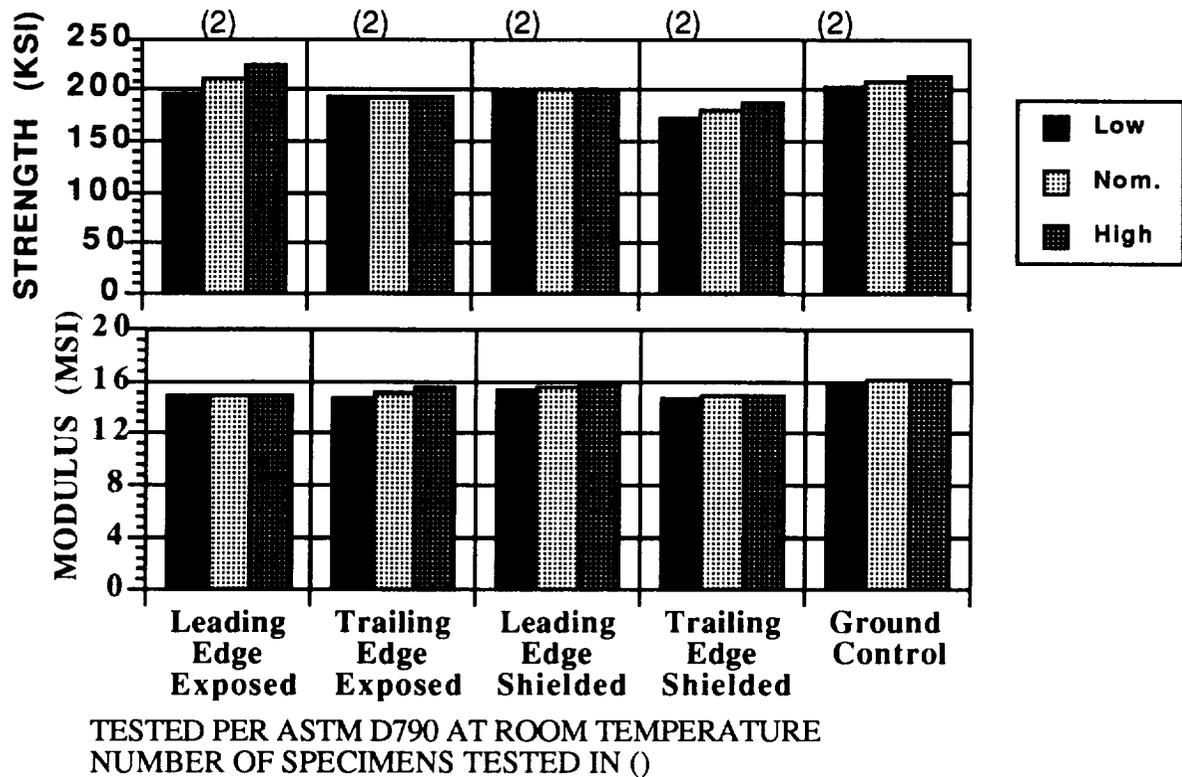
Figure 5. Strength and modulus of 3501-6/AS specimens, (0°) 16 plies

The 3501-6 epoxy/AS graphite flexure test results show very little change in modulus values among the different exposure conditions and the ground control. The strength values show some variation from position to position, most likely due to the inherent scatter with polymer matrix composite strength measurements and the small sample size. Once again the 0° orientation of the reinforcement allows the underlying plies to pick up the load from the eroded surface ply on the leading edge exposed specimens. This is a similar situation to the 934/T300 results where mechanical performance reductions are due to erosion of material on the leading edge specimens.

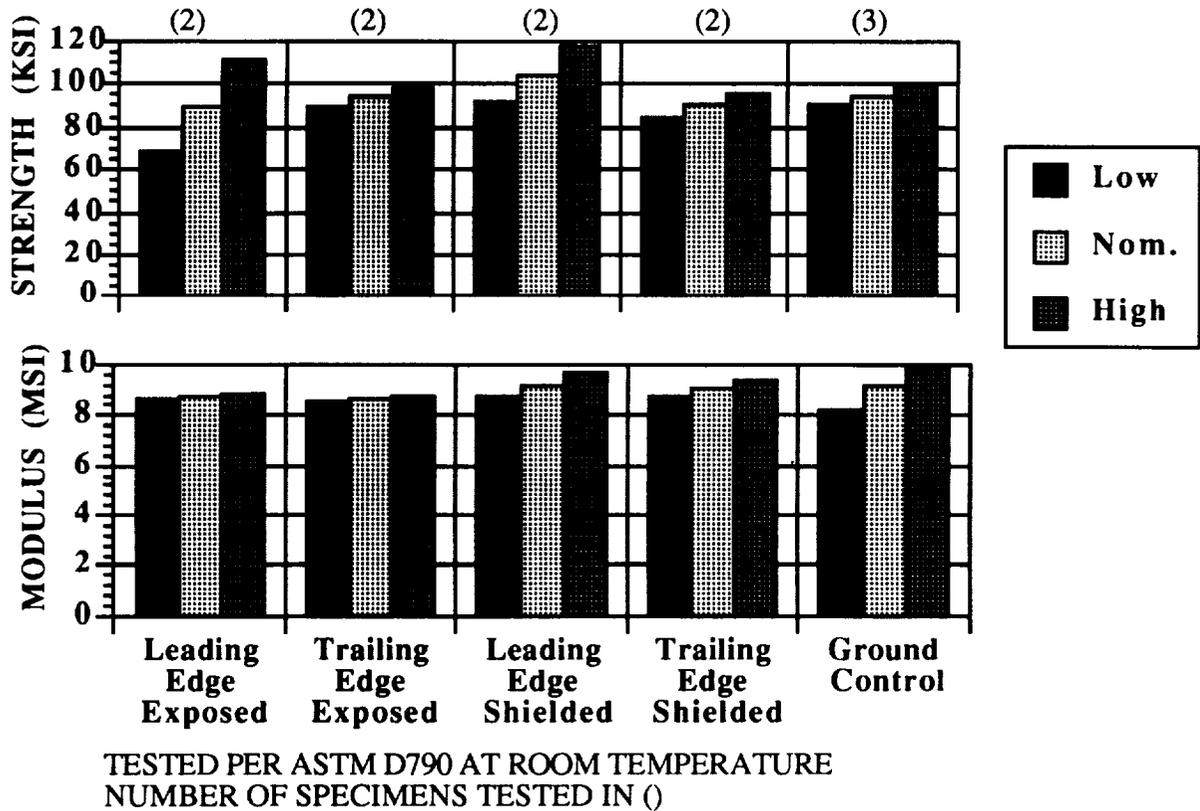
Figure 6. Flexure strength and modulus for P1700/T300 specimens, (0°,90°) fabric 8 plies.

The P1700 polysulfone/T300 graphite specimens were reinforced with a 0°,90° woven fabric. Here also as with the unidirectionally reinforced specimens there is continuous reinforcement in the load direction in each ply. No significant changes in either flexure modulus or strength were found.

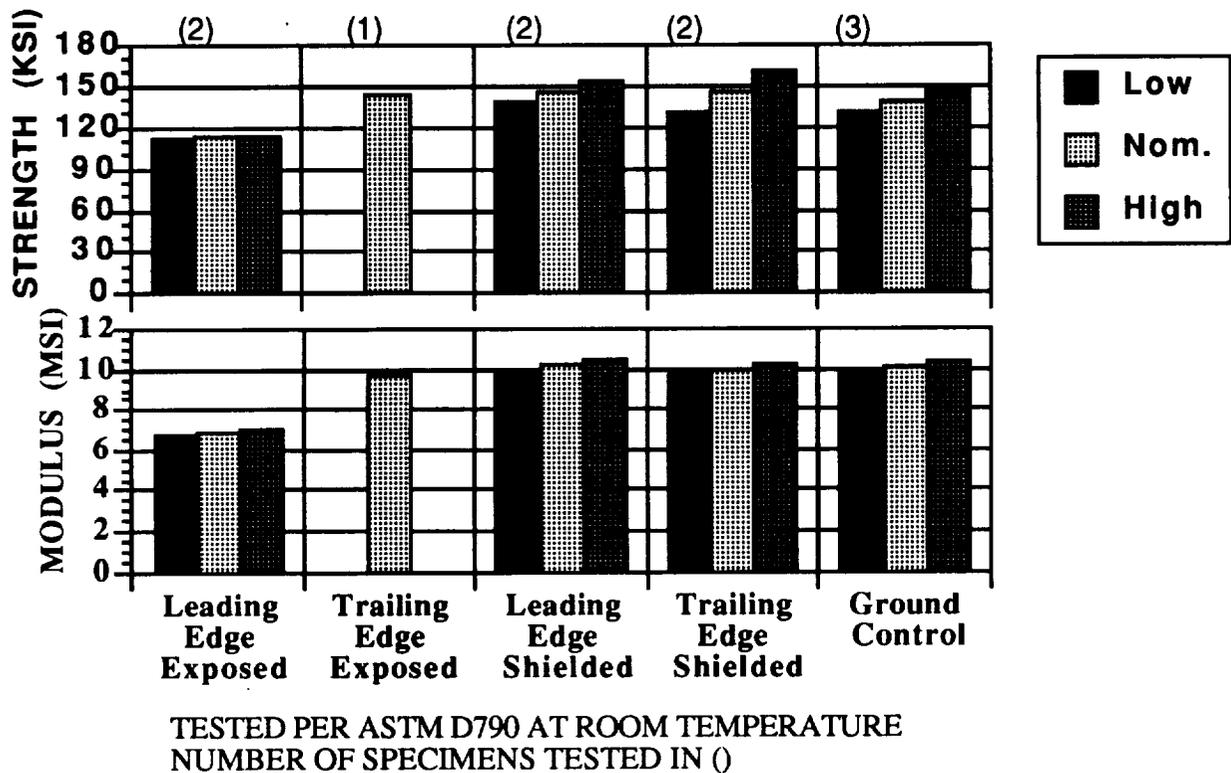
Figure 7. Flexure strength and modulus for PMR-15/C6000 specimens $(0^\circ, \pm 45^\circ, 0^\circ, \pm 45^\circ)_s$

The PMR-15 polyimide/ C6000 graphite specimens were reinforced with an angle ply stacking sequence of $(0^\circ, \pm 45^\circ, 0^\circ, \pm 45^\circ)_s$. As can be seen from the data in Figure 7 the strength and modulus values drop off significantly for the leading edge exposed specimens. This is due to the almost complete loss of the 0° ply on the exposed surface of the specimen due to AO erosion. Unlike the unidirectionally reinforced specimens, the ply underneath is at $+45^\circ$ and has a lower stiffness and strength in the load direction. This behavior has been seen in other leading edge LDEF specimens with multidirectional reinforcement.²

The non AO exposed specimen data show no significant change in flexure properties compared with the ground control data.

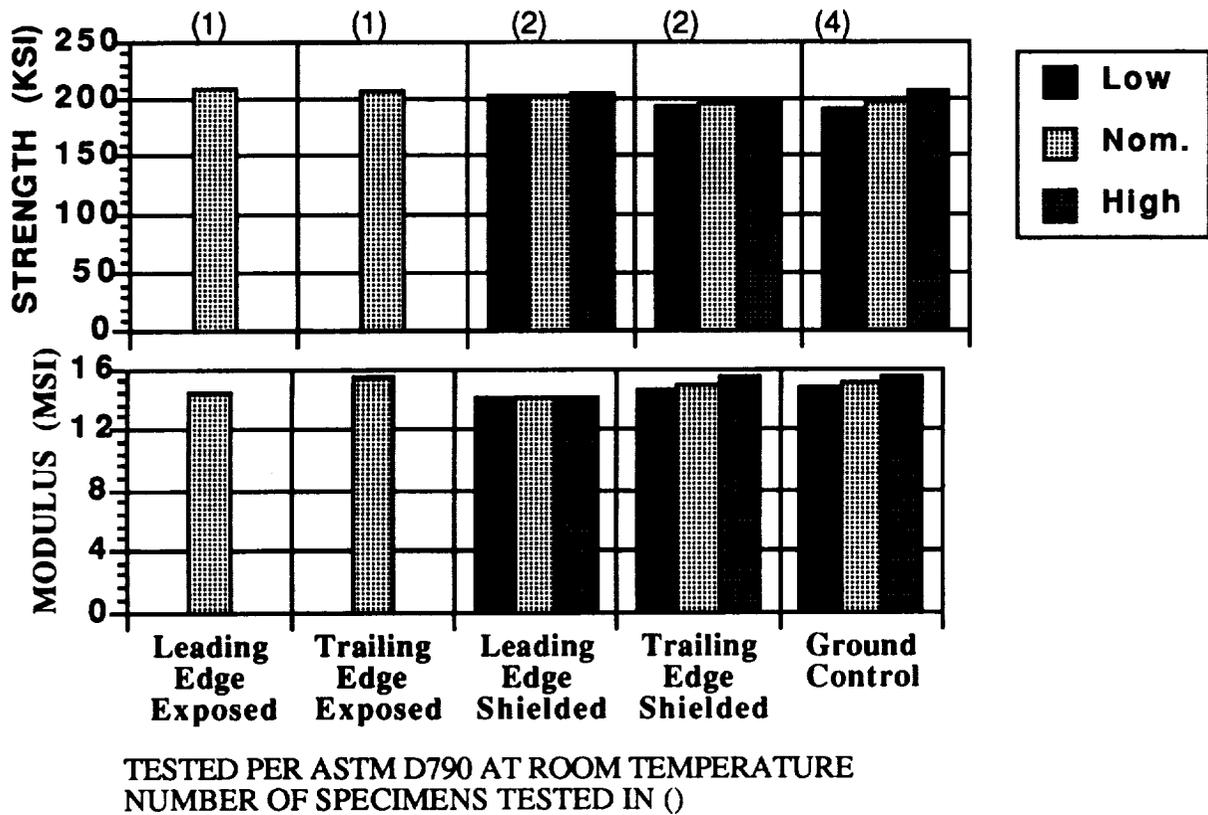
Figure 8. Flexure strength and modulus for LARC 160/graphite specimens, (0°)

The LARC 160 polyimide/ graphite flexure test results show very little change in modulus values among the different exposure conditions and the ground control. The strength values show some variation from position to position, most likely due to the inherent scatter with PMC strength measurements and the small sample size. Once again the 0° orientation of the reinforcement allows the underlying plies to pick up the load from the eroded surface ply on the leading edge exposed specimens. This is a similar situation to the other unidirectionally reinforced material results where mechanical performance reductions are due to erosion of material on the leading edge specimens.

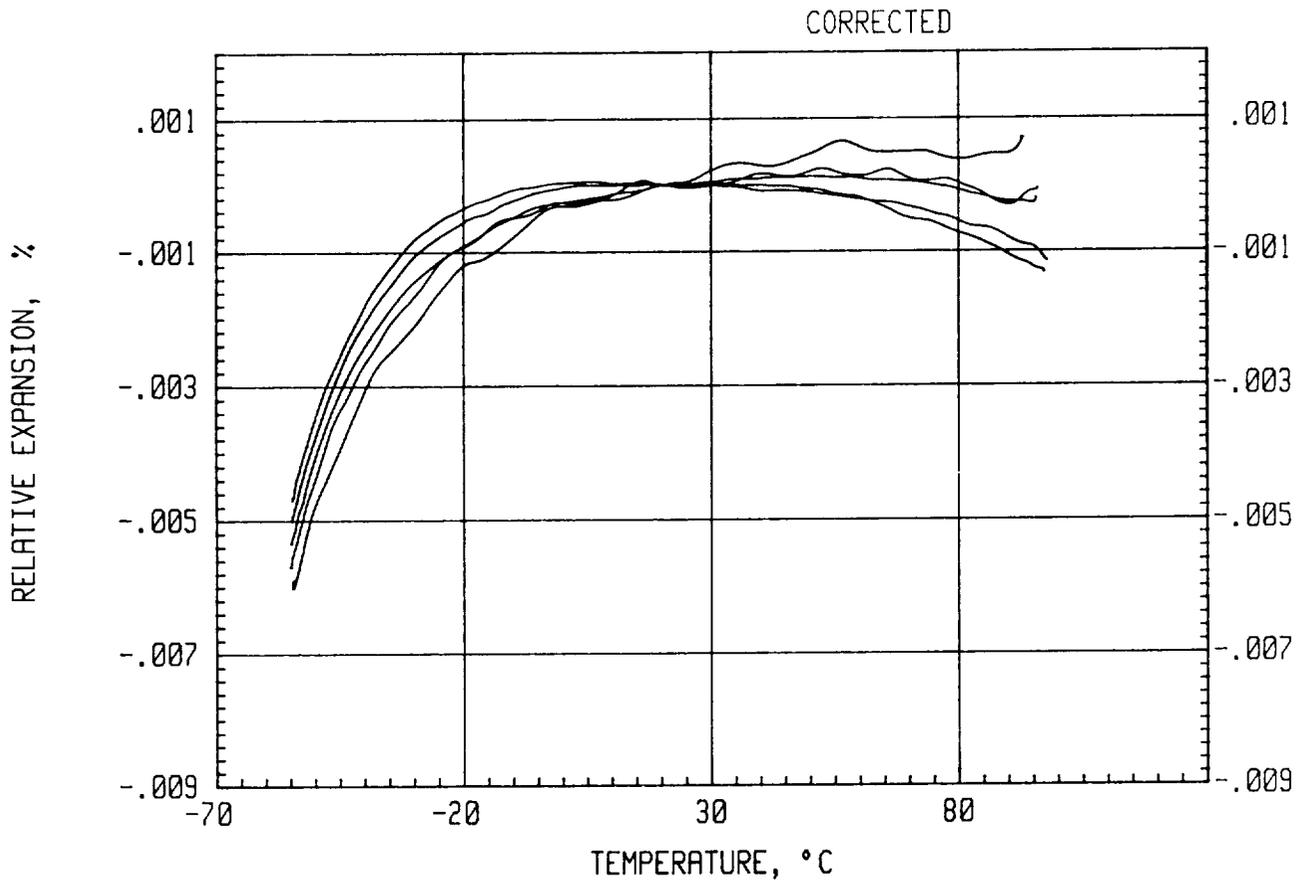
Figure 9.- Thermal expansion properties of PMR 15 polyimide/C6000 graphite LDEF specimens

Thermal expansion coefficients were measured in the 0° direction for each material using a Netzsch model 402 dilatometer. The dimensional change vs. temperature plots for the PMR-15 polyimide/C6000 graphite specimens shown in Figure 9 are representative of all the composite specimens. This plot includes values for leading and trailing edge shielded and exposed specimens as well as the ground control. The accuracy of this measurement technique is approximately 0.001% relative expansion as plotted. Therefore these measurements indicate no significant change in thermal expansion properties. However, as will be discussed in the following section, significant variations in microcracking in the PMR-15 polyimide / C6000 graphite specimens were found. This technique for measuring thermal expansion properties is not sensitive enough to measure the impact of this microcracking.

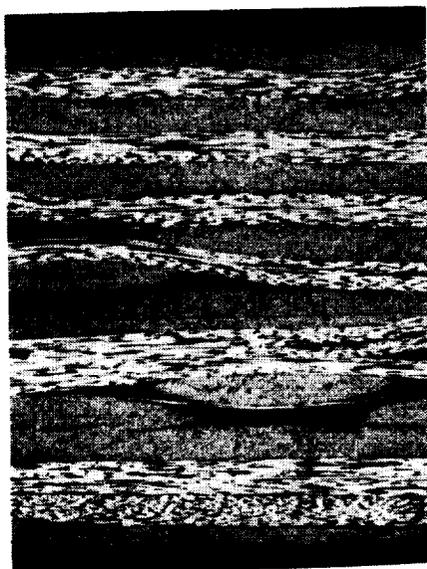
Figure 10. Cross sectional micrograph of graphite reinforced polysulfone and polyimide specimens from the exposed leading edge position

Figure 10 shows a magnified cross sectional view of the leading edge P-1700 polysulfone/T300 graphite and PMR 15 polyimide/C6000 graphite specimens. These photomicrographs were taken at 50X and 100X magnification respectively. Intralaminar cracking can be seen in the outer plies of both specimens.

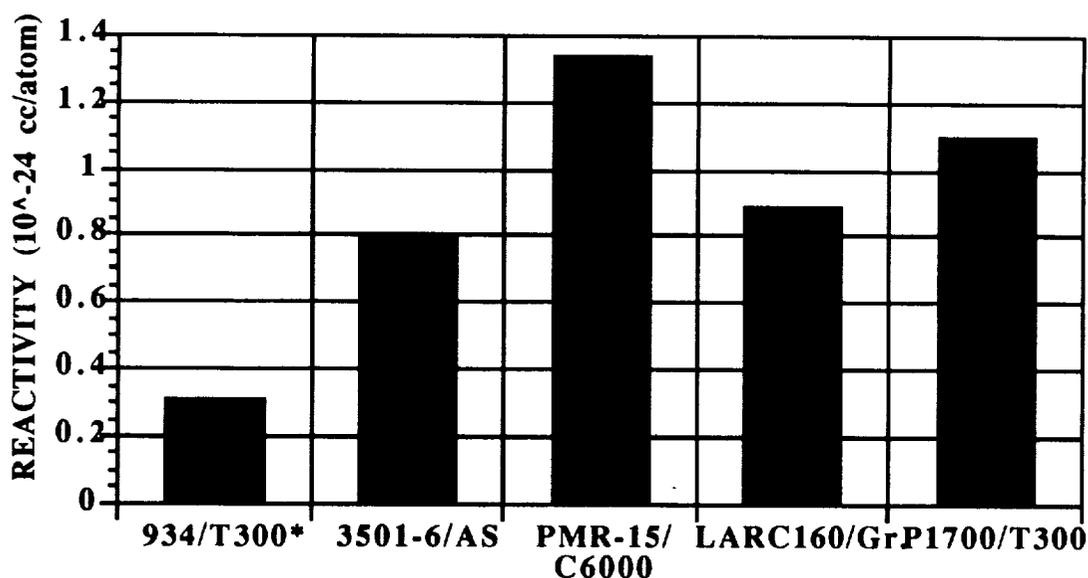
Figure 11. Atomic oxygen reactivity for leading edge exposed specimens

Atomic oxygen reactivity values shown in Figure 11 for the five composite systems flown were calculated based on mass loss data. These values do not correspond well to the relative levels of local material loss as observed using optical microscopy. This suggests that other factors are involved in the mass loss of the whole specimen. Local areas of surface contamination were observed using scanning electron microscopy on many of the specimens. These areas appear to have experienced reduced or no erosion due to shielding by the contaminants. Other areas were observed with reduced erosion and no surface contaminant suggesting that a contaminant may have provided temporary shielding from atomic oxygen attack. Reactivity values for composite systems and any other material may best be obtained through local thickness loss measurements near a shielded area by microscopy or profilometry.

Calculated from weight loss data measured at the Aerospace corporation

* This value not consistent with cross sectional analysis

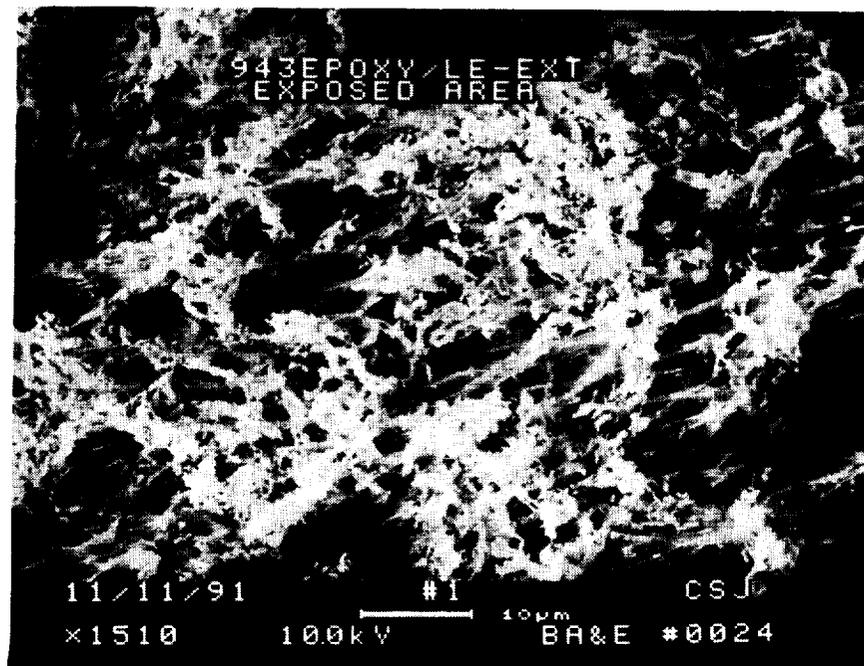
Figure 12. Scanning electron photomicrograph of leading edge exposed 934 epoxy/T300 graphite surface

Figure 12 shows the surface of a 934 epoxy/T300 graphite specimen. A jagged peak like structure exists with a stringy, "ash" like material concentrated in clumps around the peaks. The jagged peaks and "ash" structures are ubiquitous among the graphite reinforced specimens. However the level and texture of these features differ from composite type to composite type.

Figures 12 through 16 are scanning electron photomicrographs of leading edge specimens. Metallic coating of the specimens was not necessary as the conductivity of the graphite reinforcement was found to be sufficient. Perspectives and magnifications for each figure are similar allowing qualitative comparison of features.

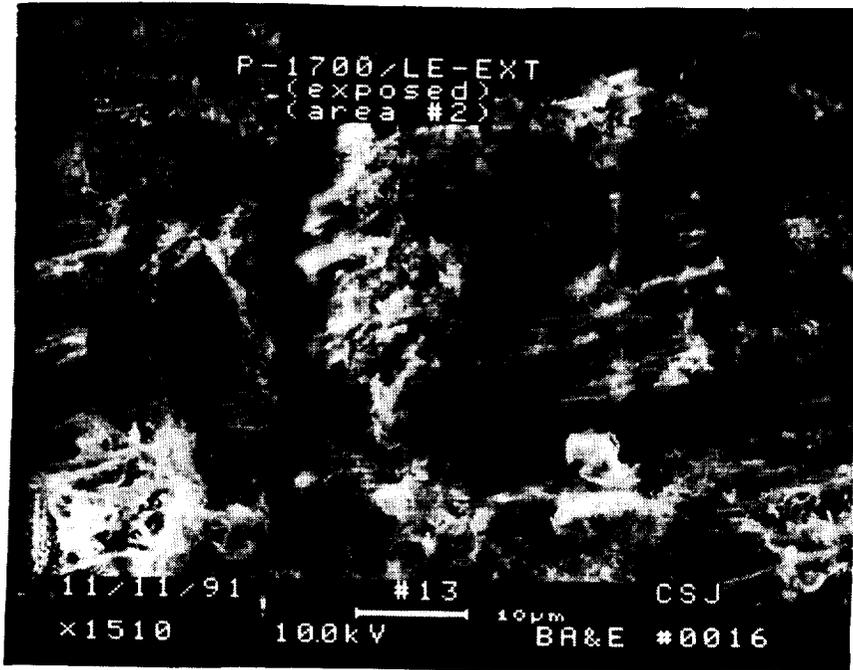
Figure 14. Scanning electron photomicrograph of leading edge exposed P1700 polysulfone/ T300 graphite surface

Figure 14 shows the surface of a leading edge exposed P1700 polysulfone/ T300 graphite specimen. The size and texture of the jagged peaks and "ash" structure are more similar to the epoxies than the polyimides. The "ash" level appears to be less than with the epoxies and greater than the polyimides. Also visible in the photomicrograph are lines along the walls of the jagged peaks. It is not known whether these lines correspond to the fiber direction.

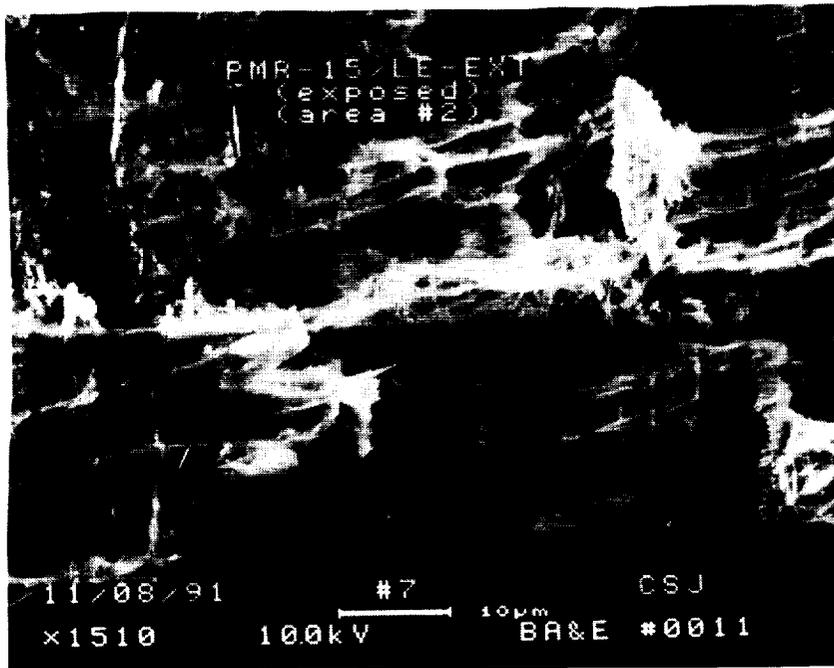
Figure 15. Scanning electron photomicrograph of leading edge exposed PMR-15 polyimide/C6000 graphite surface

The "ash" level for the PMR-15 polyimide/C6000 graphite shown in Figure 15 appears to be significantly lower than that of the epoxies. This "ash" is of a much finer texture resembling "cobwebs". Previous SEM work with LDEF specimens using metallic coatings to reduce charging did not reveal this structure for the PMR-15 polyimide.² The "ash" structure for the 934 epoxy specimens employing a metallic coating was visible and intact. This indicates that the "ash" structure for the PMR-15 polyimide is extremely delicate. The size and spacing of the jagged peaks for the PMR-15 polyimide appear larger than that of the epoxies.

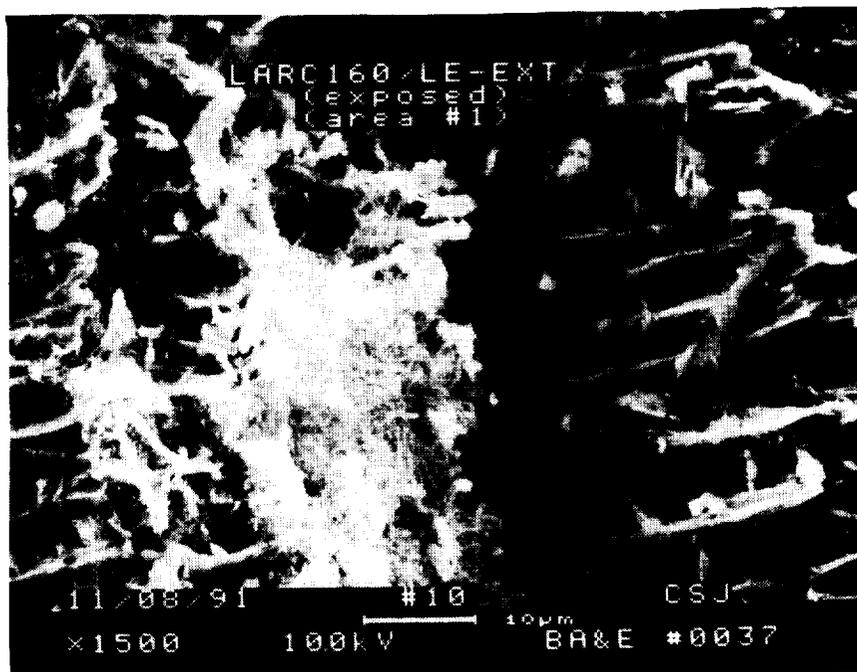
Figure 16. Scanning electron photomicrograph of leading edge exposed LARC 160 polyimide/graphite surface

Figure 16 shows the surface of a leading edge exposed LARC 160 polyimide/graphite specimen. The jagged peak size and spacing appear similar to the PMR-15 polyimide. The "ash" structure also appears similar with more "clumps" present. An area of contamination can be seen just to the left of the center. These areas were common on all leading edge exposed surfaces.

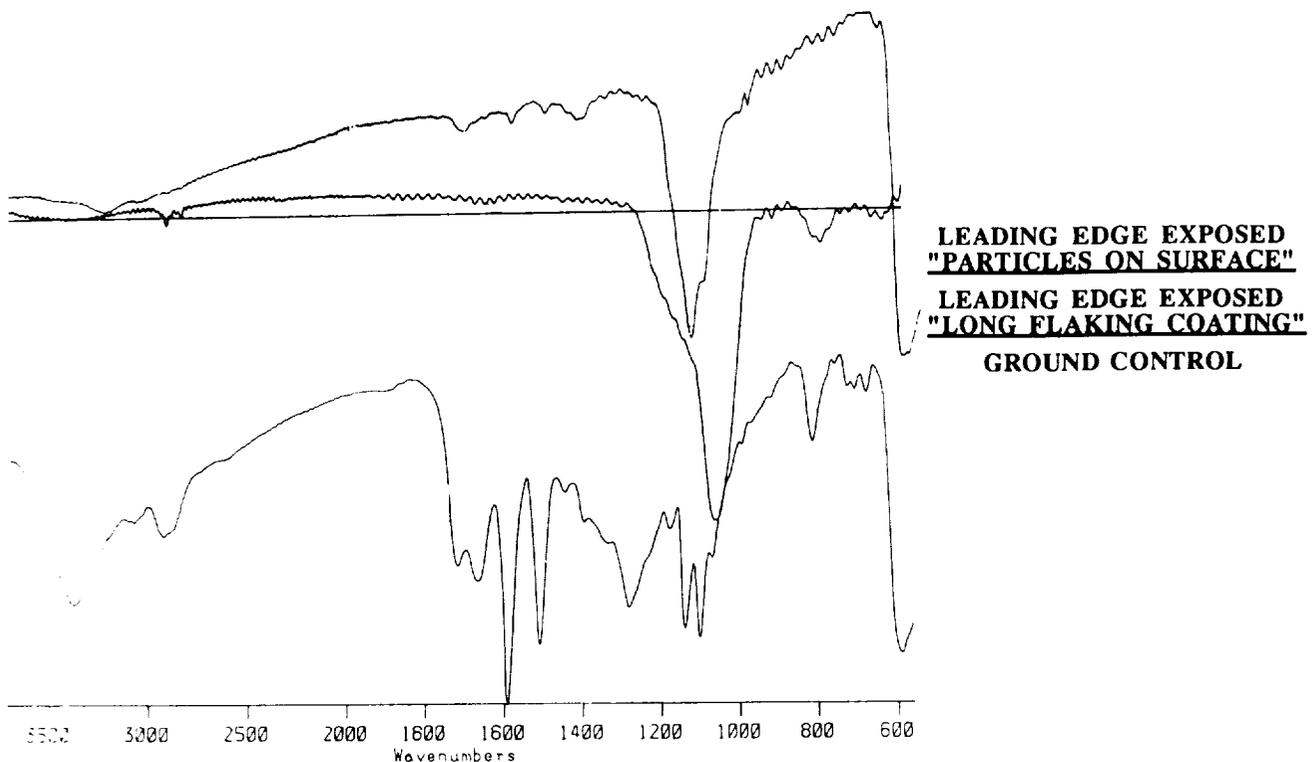
Figure 17. FTIR spectroscopy trace for 934 epoxy/T300 graphite specimens

Figure 17 shows post flight infrared spectroscopy (IR) traces for material taken from two areas on the leading edge exposed surface of the 934 epoxy/T300 graphite specimen. An IR trace for the ground control specimen is also included. A Bio Rad Digilab FTS-60 fourier transform IR spectrometer equipped with a UMA 300A IR microscope was used to make all IR measurements.

Some obviously significant changes have occurred to the surface of these specimens during LEO exposure. The two leading edge exposed surface traces indicate that little if any of the original matrix material is present on the surface. Both traces are dominated by broad single peaks with various shoulders. The "long flaking coating" trace peak matches that of a silicate indicating that this material may be a contaminant. The "long flaking" appearance is consistent with that of other ubiquitous LDEF silicate contaminants.

The peak for the "particles on surface" trace is clearly shifted to the right compared to the silicate peak. This material is the "ash" seen on the surface of the exposed 934 epoxy specimen SEM photomicrographs.

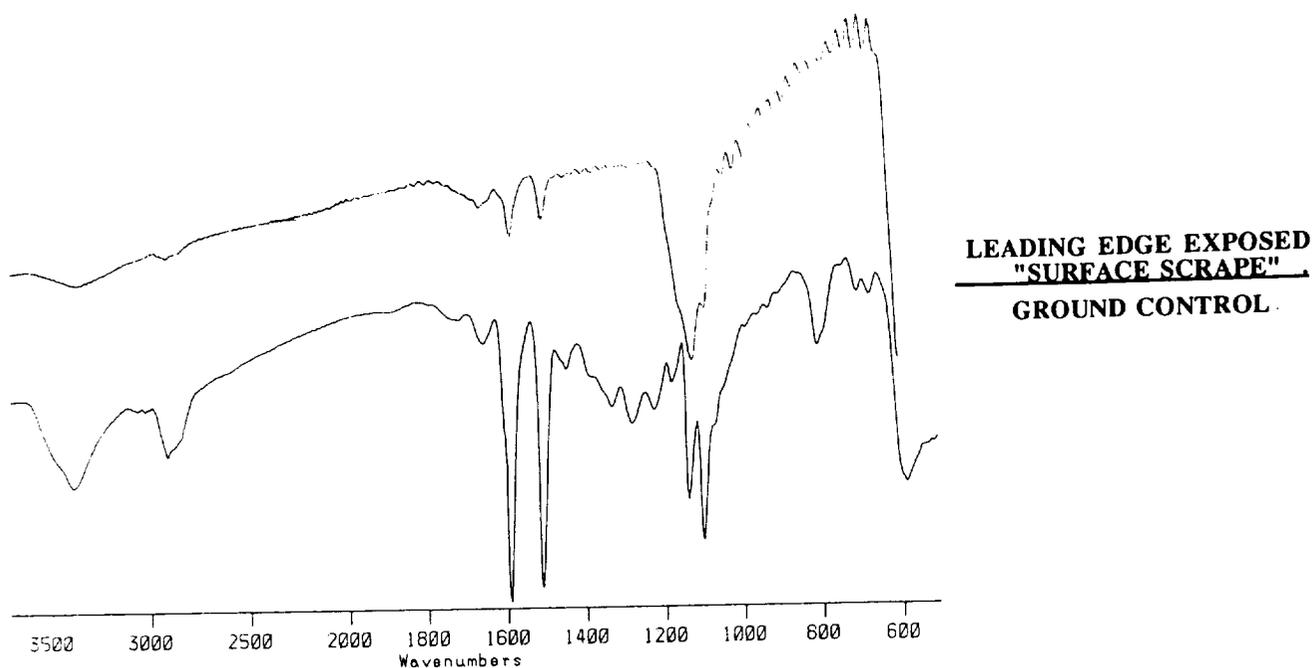
Figure 18. FTIR spectroscopy trace for 3501-6 epoxy/AS graphite specimens

The IR spectroscopy traces for the 3501-6 epoxy/AS graphite in Figure 18 resemble those of the 934 epoxy. The peak on the "surface scrape" trace occurring in the 1100-1200 wavenumber region matches that of the peak from the 934 epoxy "particles" trace. These peaks match the IR spectra of sodium sulfate very well as reported in earlier efforts.² The presence of a peak in this area has also been reported for 5208 epoxy/T300 graphite leading edge exposed specimens.⁴ The presence of sodium and sulfur on the 934 epoxy surface has been detected by EDX and is reported later in this paper. Also, X-ray diffraction techniques have confirmed the presence of orthorhombic crystalline sodium sulfate with a high degree of confidence for both the 934 epoxy and P1700 polysulfone composites. This suggests that sodium sulfate is present in the ash of both the 934 epoxy and P1700 polysulfone leading edge exposed specimens.

The presence of sodium sulfate on only certain polymer matrix composites suggests that contamination from other LDEF sources is improbable. One possible source of this compound is that residual sodium contamination from manufacture of graphite fiber tows is combining with sulfur from the composite matrix material curing agent to form AO resistant sodium sulfate. This may offer an explanation for the light and dark banded pattern reported for a 5208 epoxy/T300 graphite specimen flown on LDEF.⁵ The banding may be due to variations in the residual levels of sodium in or on the carbon fiber tows from the manufacturing process.

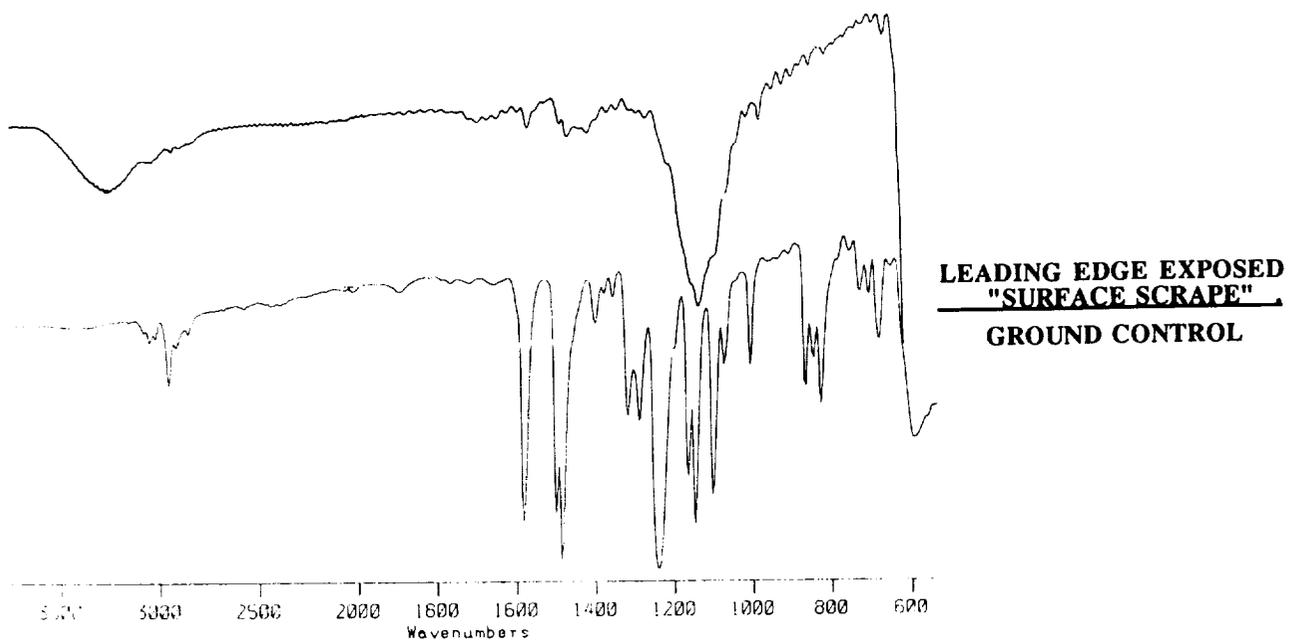
Figure 19. FTIR spectroscopy trace for P1700 polysulfone/T300 graphite specimens

The IR trace for the leading edge exposed P1700 polysulfone/T300 graphite as shown in Figure 19 also shows the presence of a broad peak in the 1100 to 1200 wave number region. Comparison to the ground control indicates that most of the matrix resin has been eroded from the surface. As mentioned previously the presence of sodium sulfate has been found on the surface of the P1700 polysulfone/T300 graphite leading edge exposed specimens using X-ray diffraction. The source of sulfur in this case may be the sulfur incorporated into the backbone of this polymer system.

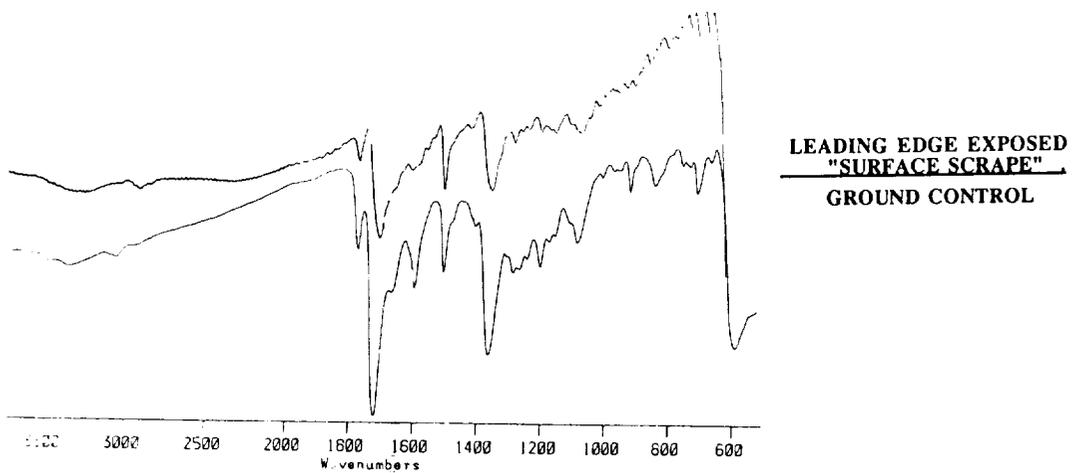
Figure 20. FTIR spectroscopy trace for PMR-15 polyimide/C6000 graphite specimens

Figures 20 and 21 show the IR traces for the PMR-15 polyimide/C6000 graphite and LARC160 polyimide/graphite leading edge exposed surface and ground control specimens. These spectra are very similar reflecting their similar chemistry. Unlike the epoxy and polysulfone exposed surfaces the polyimides appear to have retained more characteristic peaks for the matrix material indicating more exposed polymer remaining on the surface. The only significant differences are disappearance and/or weakening of peaks and shoulders at 1660, 1600, and 930 wave numbers from the ground control to the exposed trace. These differences were also present for the PMR-15 polyimide/C6000 graphite specimens examined from experiment M0003-8.² Changes in absorption in these bands may be attributable to changes in the carbonyl linkages between the phenyl rings.⁶ This area warrants further investigation as these changes may offer insight into the chemical breakdown mechanism of polyimides in an atomic oxygen environment.
